ARCHITECTURAL TECHNOLOGY

Conservation 2

Historic building material and technology

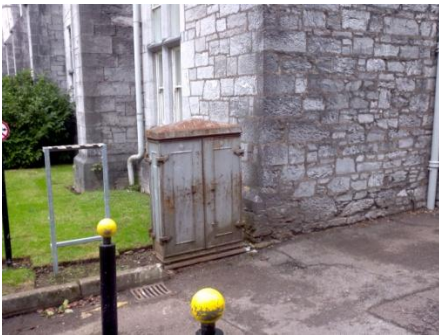
(Fig 2.1- External wall)

Here we see the solid Limestone wall meeting the concrete ground. As you can see from the photo the wall is very well kept as is the limestone mortar holding it together. Other things to note from this photo are the more modern plastic PVC gutters which have replaced some of the old cast iron gutters. The gutters are the same colour as the original ones but are constructed of a different material and are therefore identifiable from the originals.

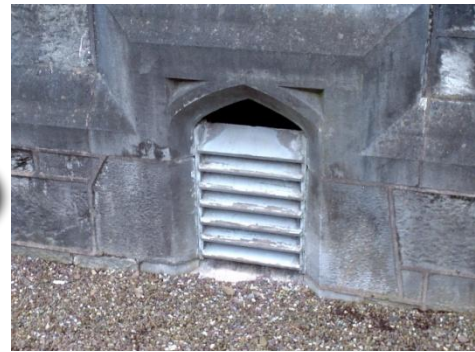
The solid Limestone wall is meeting the concrete ground. There is some form of vent incorporated in this case. This vent is constructed of oak timber and is most likely used to ventilate the basement .It has not been properly maintained or conserved. The paint is peeling off in places and there appears to be pieces of timber missing.

(Fig 2.2- External vent)

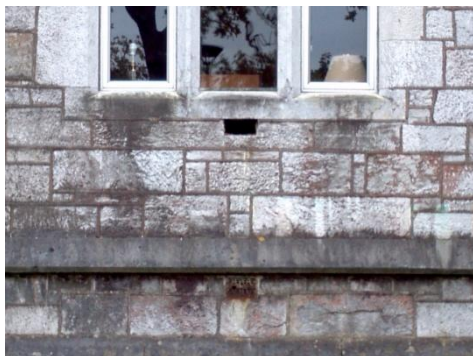
(Fig 2.3- External wall)

Directly beneath the window is a solid limestone cill and beneath that again in the centre of the wall is a gap which is used to ventilate the area around the window. There is also a limestone plinth located in the image which slopes out from the wall. Beneath this plinth there is a cast iron vent. This vent is used to ventilate the floor area internally. The vent is in poor condition and in need of repair.

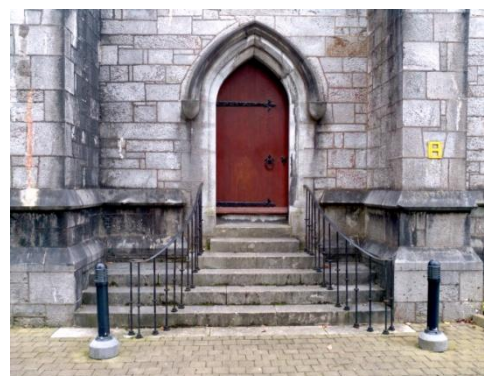
This is a ground floor entrance to the Auala Maxima. There is a limestone frame wrapping around the solid oak door which has been varnished. It also has a design piece running along the head of the door. The ironmongery on the door consists of cast iron that is painted black. There are solid limestone steps leading up to the door. From the picture it can be seen that there are little bits of staining around the place but other than that all other materials in this image are well maintained.

(Fig 2.4- External door)

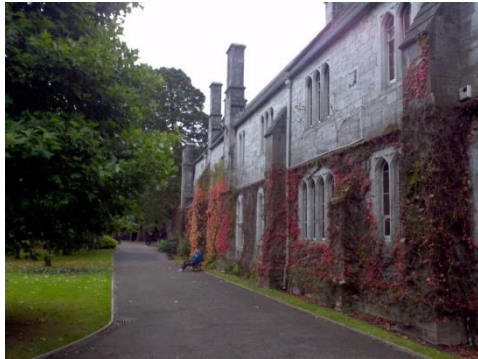
(Fig 2.5- External wall)

This is an external image of the east wing. In this image we can see a number of buttresses running up along the building vertically. These buttresses are constructed of solid limestone and their purpose is to solidify the building and make it more rigid. Ivy growth can also be seen running along the face. This growth has accumulated over the years. This has however become a feature of the building and at this time is not causing any risk to the structural

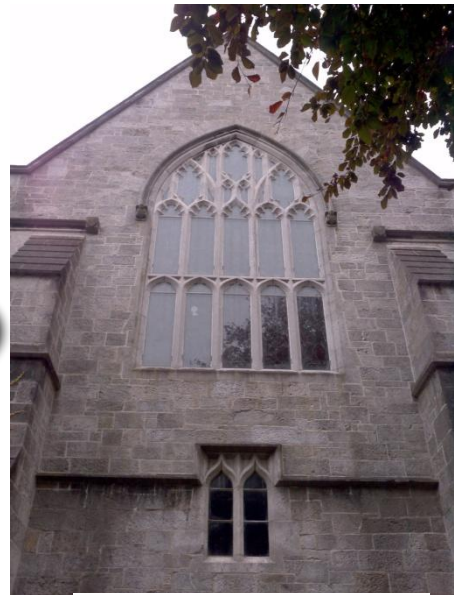
This is the East wall of the Aula Maxima. There is a large stained glass window covering most of the elevation. The window has been divided up using stone mullions. Nearly all of the windows throughout the Quad are vaulted in some way. The windows of the Aula Maxima are in good condition and do not need to be repaired or replaced.

(Fig 2.6- Aula Maxima)

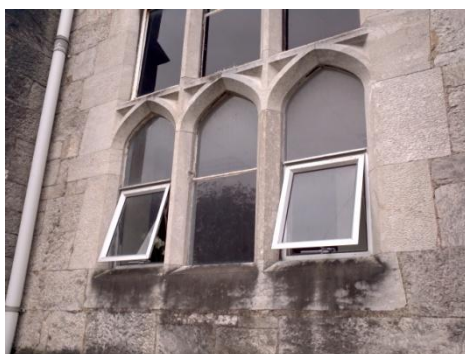
(Fig 2.7- External windows)

These windows located throughout the rest of the Quad building. They are again divided up using stone mullions. The glass has been divided up using aluminium strips. In recent times there has been an incorporation of opening sashes in the windows throughout the Quad. They were installed to ventilate the building and consist of an aluminium frame. There is fenestration in the windows throughout the building.

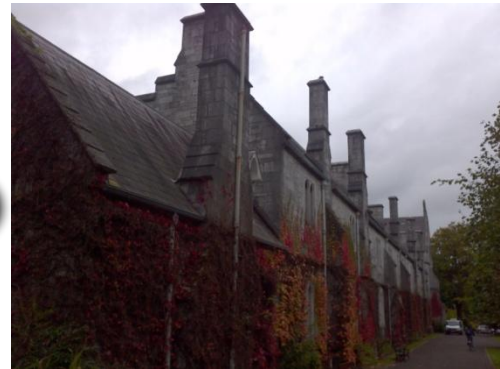
The building is constructed using a hipped roof. The roof is constructed using slate and lead strapping. There are various chimneys running up along the East wing. As you can see they are quite long and run above the roof top. They are again like the walls constructed of limestone and as can be seen from the photo, they have withstood the test of time. The roof has been re-slated and is currently in perfect condition.

(Fig 2.8- East wing)

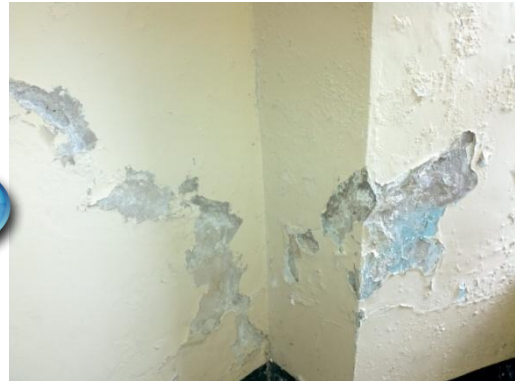
Most of the plaster throughout the Quad is very well maintained. However there are certain areas where damage is clearly visible. An example of this is shown in the image adjacent. This is not causing any structural damage but is a building defect and must be remedied properly paying close attention to detail and keeping conservation in mind at all times

(Fig 2.10- Internal plaster)

In order to repair this plaster correctly a specialist conservation contractor must be brought in. They will carefully knock away all the plaster which has been damaged beyond repair and replace it with a similar breathable form of lime plaster. This plaster will again be identifiable from the original plaster.

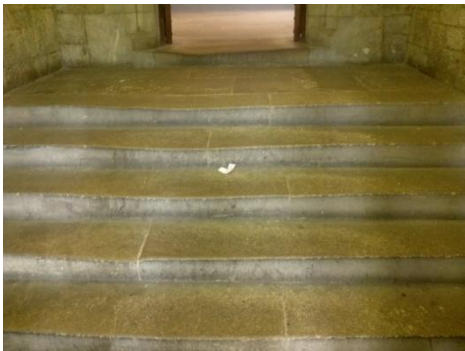
The stairs are constructed of stone and are the original stairs that were installed in the building. The stairs are quite worn in the middle, where they are being used the most. These are protected stairs and cannot simply be replaced. There are a number of these stairs located throughout the building

(Fig 2.11- Internal stairs)

As these are a highly protected part of the building they cannot simply be replaced. There are a number of solutions. Firstly the steps could be taken out, turned around and put back

into place. This would leave them with straight level and safe edges. Another method would be to simply fit the steps with grips to give people more grip when walking on the steps. The second method is the cheapest, quickest and easiest form of intervention. It will also greatly improve the safety of the steps.

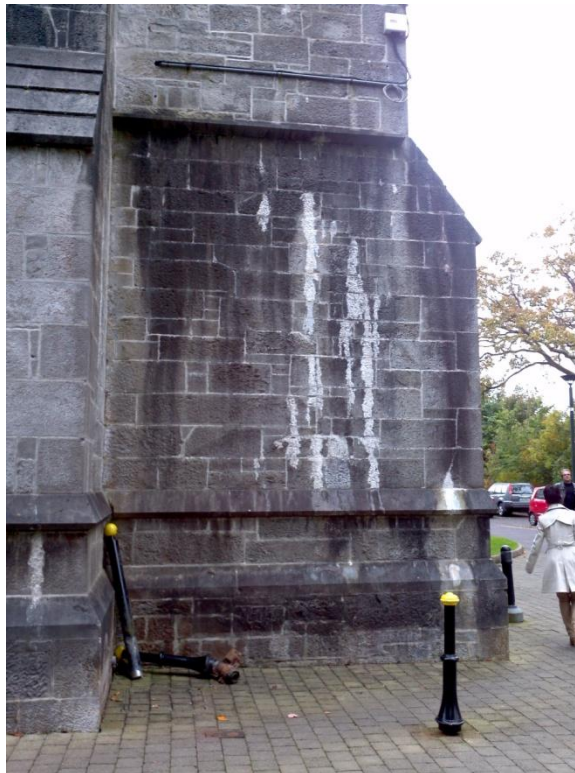
There are a number of areas in the Quad that need to be looked at in terms of preservation and repair. Externally the Quad is in very good condition however there are a few issues that must be dealt with. There are several areas of staining around the building.

(Fig 3.1- External staining)

Above is an example of the kind of staining that can be seen. To fix this you would simply clean the facade of the building. There are many different techniques available. Some are more expensive than others however they can prove more effective and less harmful to the building's facade. An example of harmful treatment would be sand blasting. However this system erodes away the facade and therefore is damaging it. A harmless way of cleaning the facade would be laser treatment. This method is much more expensive but is very effective. Therefore the laser technique is the best option as it will cause the least damage to the original structure.

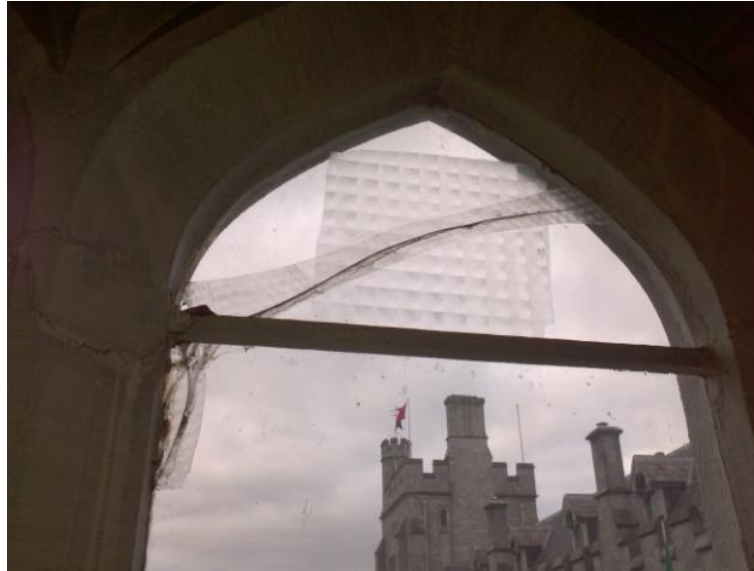
(Fig 3.2- Cracked glazing)

There are several areas of cracked glazing around the building and most of the other glazing is providing insufficient insulation. To solve this problem I would suggest the installation of double glazed vacuum glazing. This glazing is 7mm in thickness and will give the same appearance as the single glazing as well as fitting into the original framing. It will also greatly improve the overall thermal performance of the building. It is produced by a German company called 'Grenzebach'. All windows will be sealed using clear sealant in or to stop any drafts from entering the building. Some of the frames are rusted and eroded beyond repair and therefore they must be replaced. The replacement frames will look similar to the original but not the very same and therefore will be identifiable as replacements. This may seem as an extreme form of intervention but it is necessary in order to improve the buildings thermal performance and bring it up to some form of modern standards. The windows could be replaced with a like for like single pane of glazing but this would not provide sufficient thermal insulation and therefore the vacuum glazing is the best option.

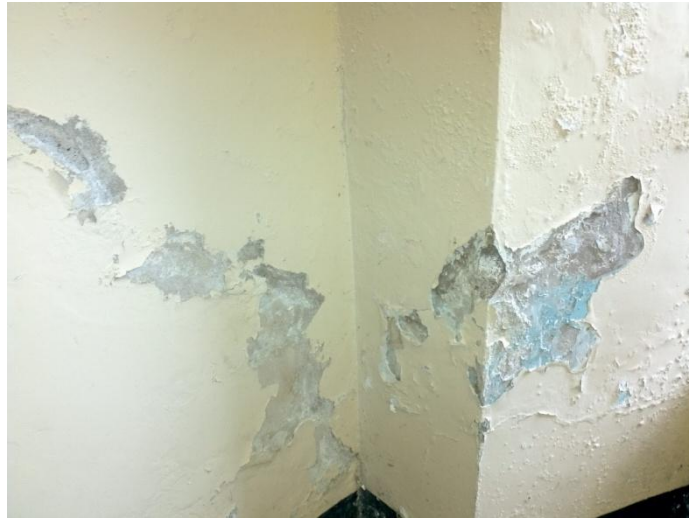
Damaged internal plaster is another issue that must be dealt with. There are areas throughout the building where damaged plaster is providing quite an eye sore.

(Fig 3.3- Internal Plaster)

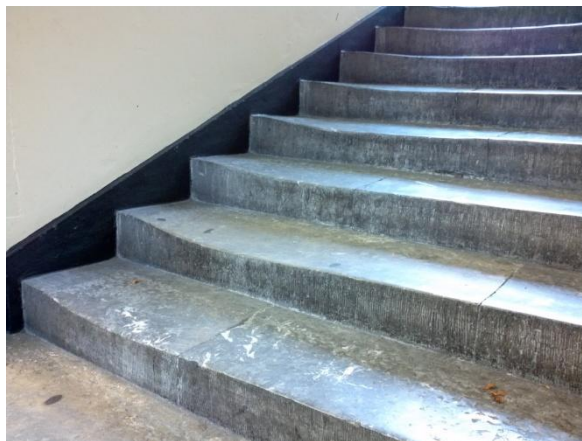
The internal stone steps are another area which must be dealt with. They are very worn in some areas and can become very dangerous when wet.

(Fig 3.4- Stone stairs)

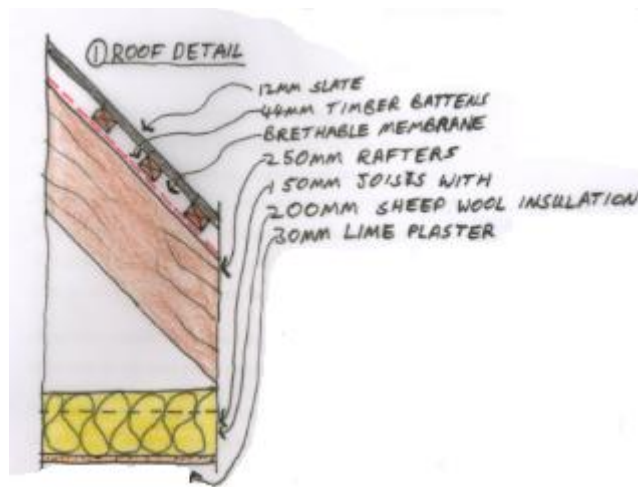
(Fig 3.6- Roof Sketch)

Finally the roof is another area which must be looked at. There is currently no insulation in the roof and this is providing a massive cold bridge for the entire building. To solve this problem a breathable form of insulation will be installed between the rafters above in the roof.
