CONCRETE HOUSE STANDS UP TO KATRINA

NOVEMBER 2013

MAKE IT STRONG

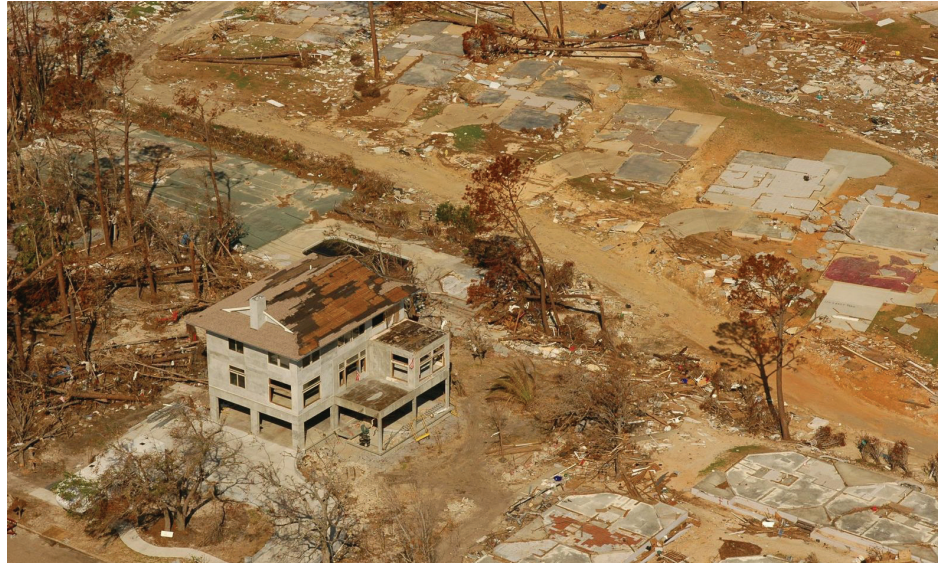
Pass Christian, MS, October 4, 2005 — Aerial photo shows the only surviving home in the area that was completely destroyed by Hurricane Katrina. Foundations are all that remain of most of the neighboring homes. The surviving home was built using many FEMA standards. Photo courtesy of John Fleck.

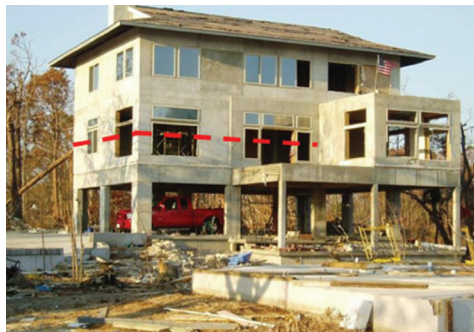
The water line was at 28 ft. as indicated by the red line in this photo.

The Sundbergs had been building their new home in Pass Christian, Mississippi, when Hurricane Katrina slammed into their area on August 29, 2005. The Category 3 storm brought with it a huge storm surge and reported sustained winds of 125 mph, bringing the water level to a reported elevation of 28 feet. When the winds died down and the water retreated to the Gulf of Mexico, the Sundbergs' home, only 85 percent complete, had survived. It was intact except for unprotected windows that blew out and some loose materials and tools, including panels upstairs that blew away.

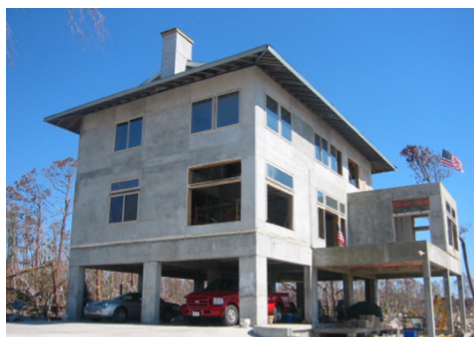
The Sundberg Home was built entirely of concrete and used Insulated Concrete Form (ICF) walls. The mitigation principles and techniques used proved effective when Hurricane Katrina and its storm surge struck a powerful blow.

A native of Thornton, Illinois, where there is a major concrete quarry, Sundberg said "concrete has been in my blood since I was young." Accordingly, when it came to building the couple's dream house, he used concrete as the main building material. The result is a sturdy house constructed of insulated concrete form (ICF) walls,

reinforced both horizontally and vertically, post tension concrete slab, concrete columns, and a concrete roof deck.

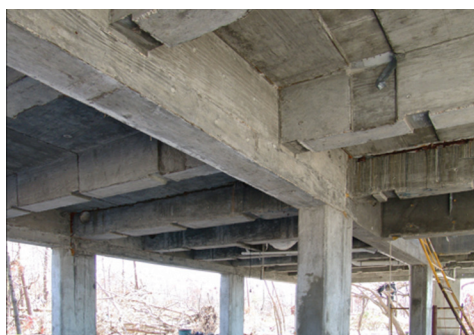
This photo clearly shows the concrete post and beam construction that supports the 3,000 sq ft structure.

The Sundbergs' house has spread footings, with concrete columns and beams to distribute the load to the soil. There is connectivity through the house from the roof down to the third floor, on to the second floor, and then to the carport. The house is also built to 'perform elastically' and to withstand winds of between 180 and 200 mph. The bottom of the beam of the first floor living space is 25.4 feet above sea level. The carport elevation is 14.8 feet. The base flood elevation for their area is 14 feet. The slab-floor level of the house is the carport and has a small interior room. This space had breakaway walls which "blew away perfectly [during Katrina]," said Sundberg.
