Witness Marks

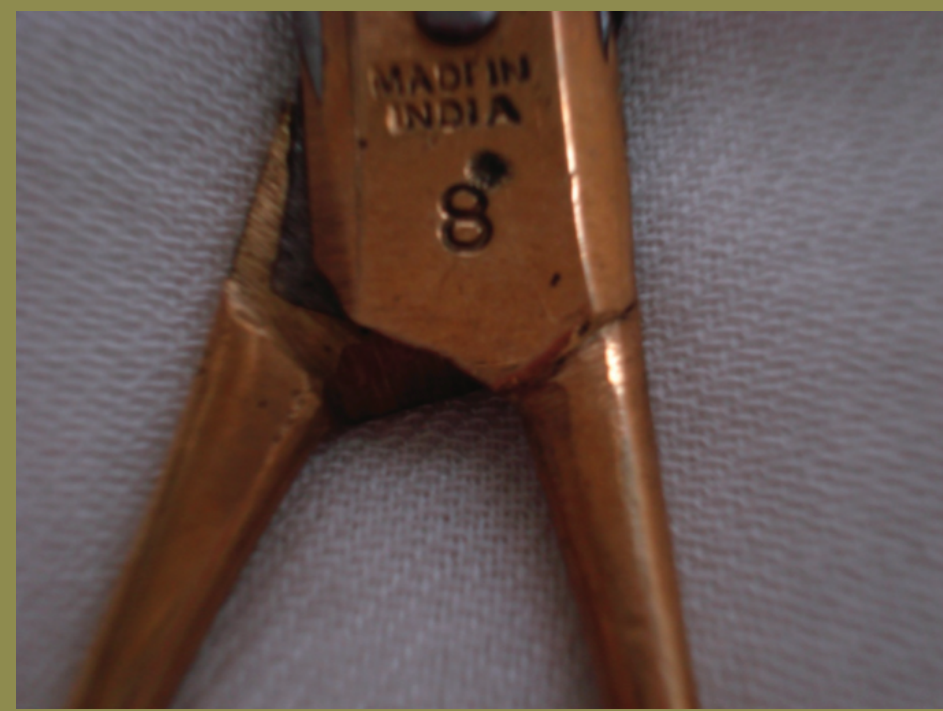
1. Markings

Identification marks of it's origins and part number can be seen on both sides of the piece.

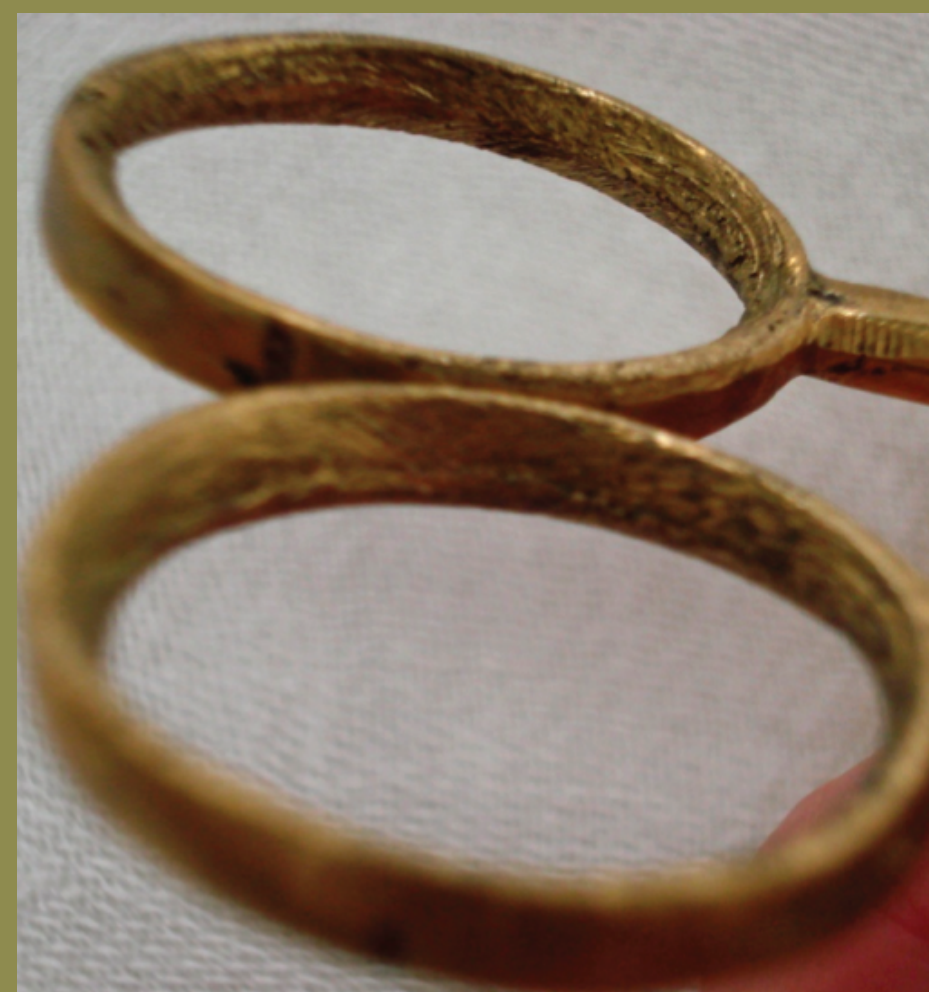
2. Parting Line

A thin line spanning the middle of each finger hole bares the signs of where a mold was connected.

There are also file/grinding marks along each ridge, perhaps trying to even out or make the parting line less visible.

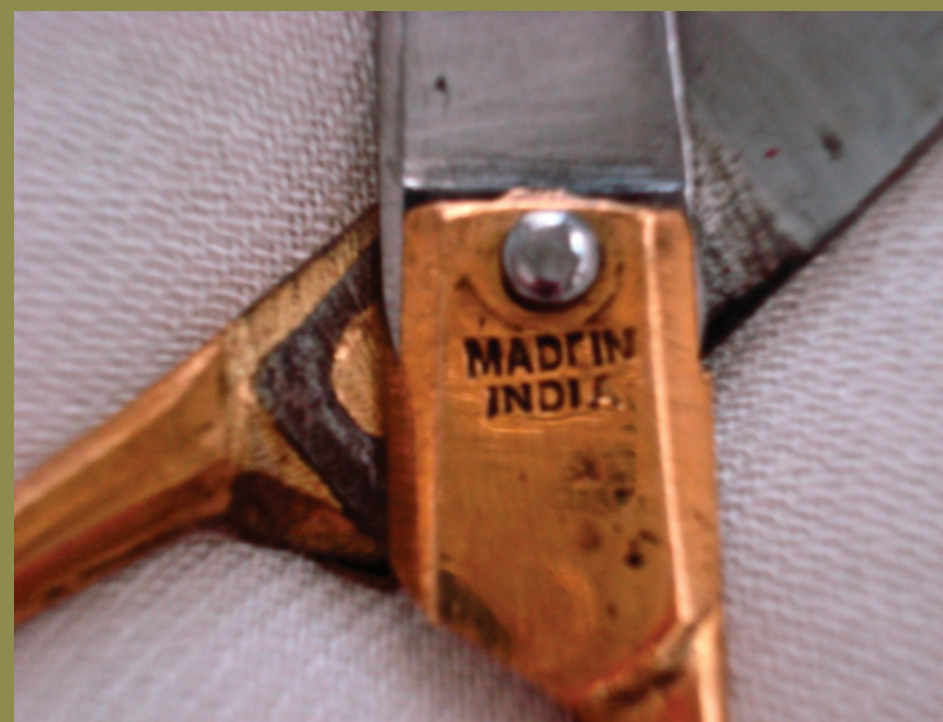
3. Tooling Marks

- Connecting pin.
- Gaps in mold, creates a rough unfinished texture on certain areas.

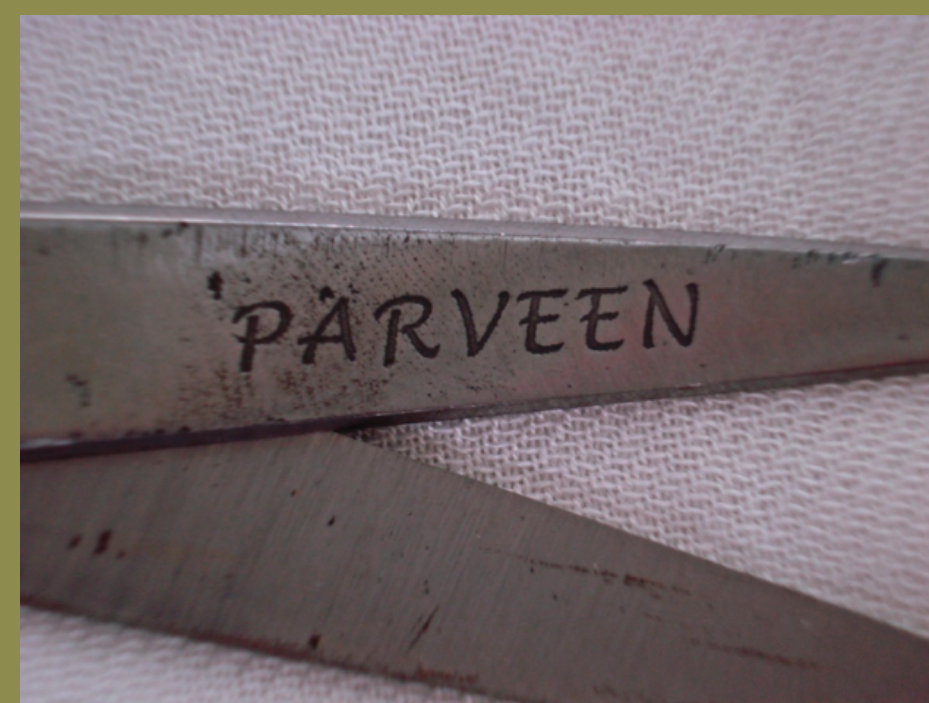
Tooling Marks cont..

- File marks from smoothing the connecting pieces.
- Dip in mold so pieces fit together properly.

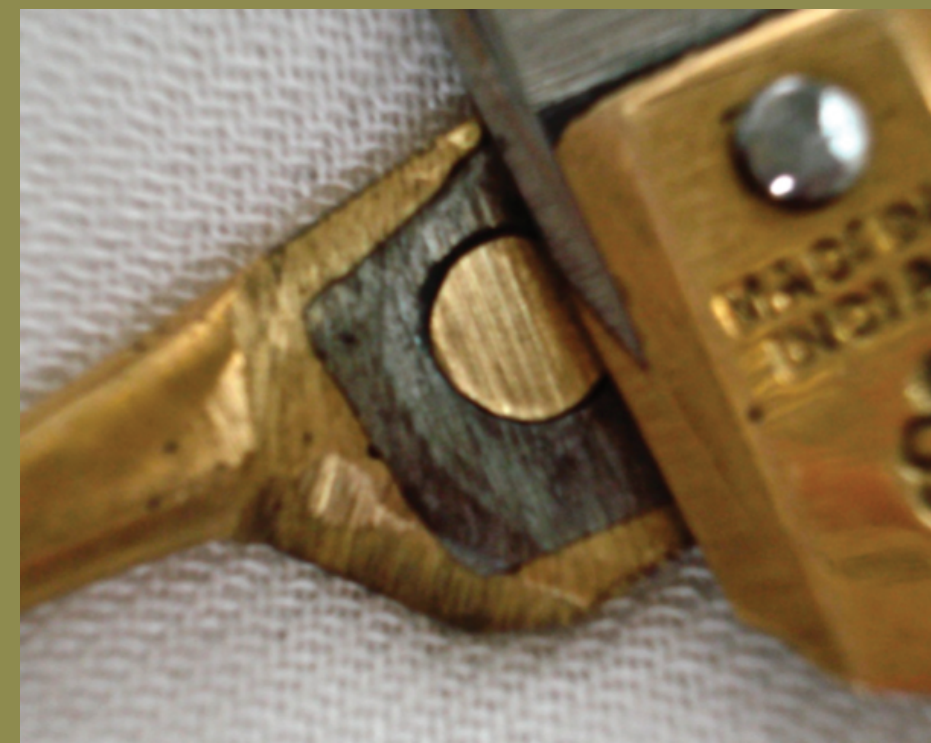
Tooling Marks cont..

- Wear and Tear.
- Identification mark.
