Institiúid Teicneolaíochta Chorcaí  
Cork Institute of Technology

## **ARCHITECTURAL TECHNOLOGY**

**Conservation**

**Building conservation**

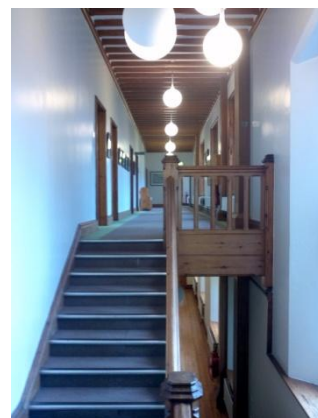
Above is an image of the internal hall of the East wing.

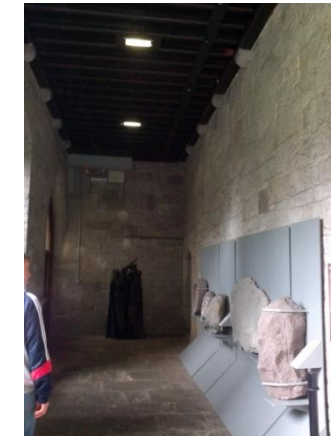
Above is an image of some of the Ogham stones located in the North wing of the Quad.

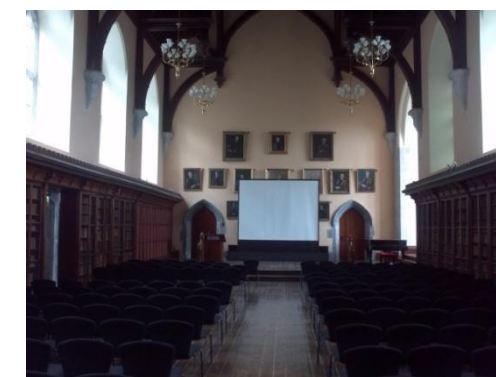
The stained window on the East wall commemorates George Boole. He was the first professor of mathematics at UCC and his findings in Algebra became the foundation of modern computer science. The Boole library was also named after him.

The window on the North wall is known as the professors window and is in memory of Robert Harkness, who was the professor of Geology in 1853.

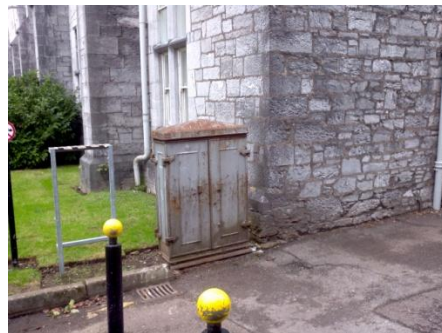
This image shows how the solid Limestone wall is meeting the concrete ground. As you can see from the photo the wall is very well kept as is the limestone mortar holding it together. Other things to note from this photo are the more modern plastic PVC gutters which have replaced some of the old cast iron gutters.

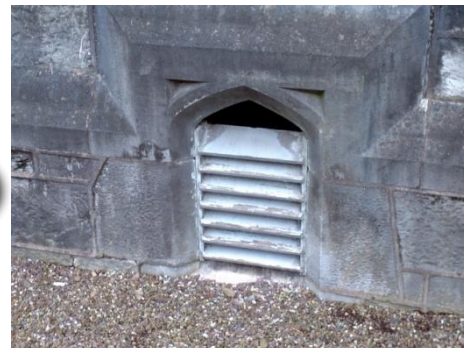
The image adjacent shows an external image of the wall with a window included. Directly beneath the window is a solid limestone cill and beneath that again in the centre of the wall is a gap which is used to ventilate the area around the window. There is also a limestone plinth located in the image which slopes out from the wall. Beneath this plinth there is a cast iron vent. This vent would be used to ventilate the floor area internally.

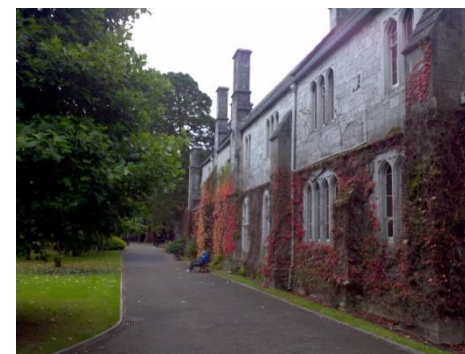
Here we can see an external image of the east wing. In this image we can see a number of buttresses running up along the building vertically. These buttresses are constructed of solid limestone and their purpose was to solidify the building and make it more rigid. This image also shows ivy growth that has accumulated over the years. This has however become a feature of the building and at this time is not causing any risk to the structural integrity of the building.

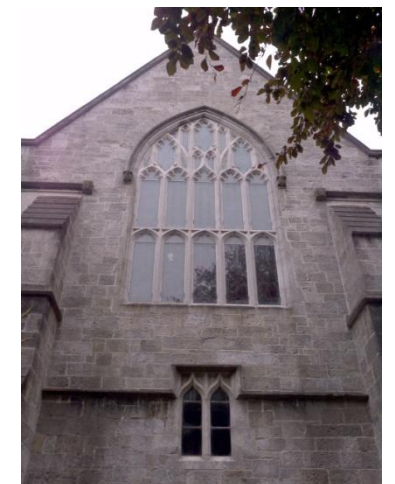
This image shows an external shot of the East wall of the Aula Maxima. There is a large stained glass window covering most of the elevation. The window has been divided up using stone mullions. The stone mullions form smaller vaulted windows. Nearly all of the windows throughout the Quad are vaulted in some way.

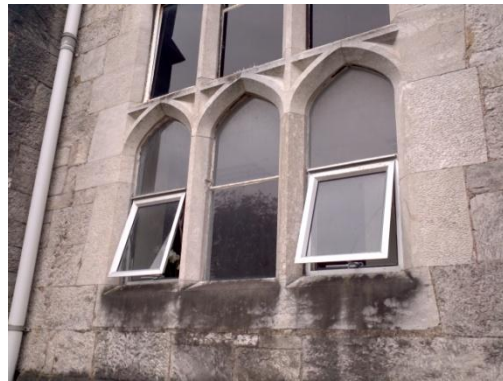
Here again we see a good example of the vaulted windows. They are again divided up using stone mullions. If we look closely we can see the glass has been divided up using an aluminium strip. However more recently there has been an incorporation of opening sashes in the bottom left and bottom right windows. They were installed to ventilate the building and consist of an aluminium frame

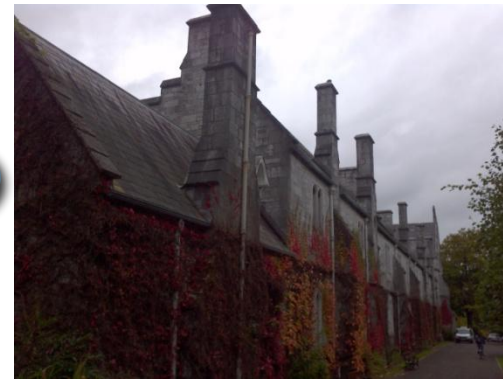
This image shows the back of the east wing. From this image we can see the building is constructed using a hipped roof. The roof is constructed using slate and lead strapping. This image also shows us the various chimneys running up along the East wing. As you can see they are quite long and run above the roof top. They are again like the walls constructed of limestone and as can be seen from the photo, they have withstood the test of time.

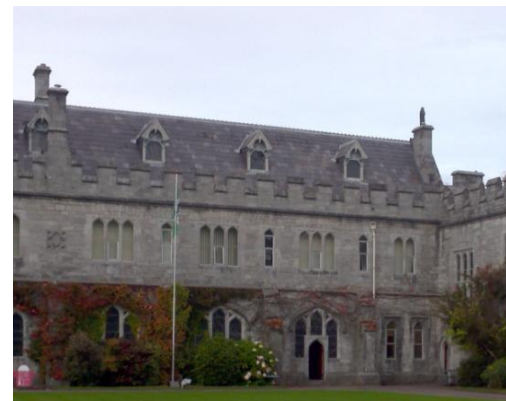
Here again we have an example of the hipped roof of the Quad, this time looking in from the front of the north wing. It is again constructed of slate and lead strapping. In this image we can also see cable windows coming out of the roof. these cable windows are constructed of oak as is the frame for the glass. There is also a parapet rising up above the bottom of the roof which can be seen better in the pictures.

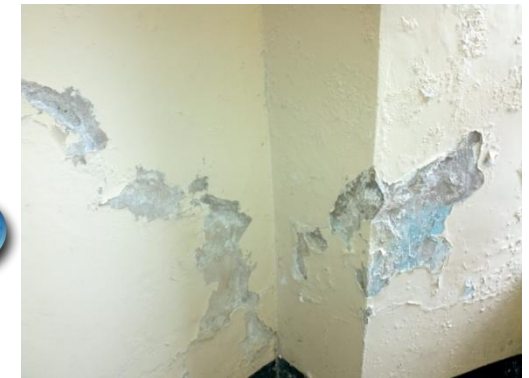
Moving to the interior of the building the first thing I am going to look at is the internal plaster. most of the plaster throughout the Quad is very well maintained. However there are certain areas where damage is clearly visible. An example of this is shown in the image adjacent. This is not causing any structural damage but is a building defect and must be remedied properly paying close attention to detail and keeping conservation in mind at all times.

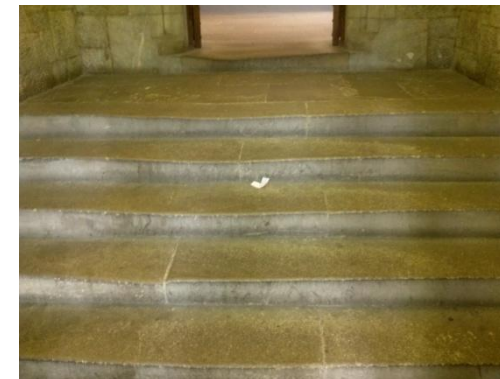
This image shows an internal shot of a small flight of stairs. The stairs are constructed of stone and are the original stairs that were installed in the building. As can be seen from the image the stairs are quite worn in the middle, where they are being used the most. These are protected stairs and cannot simply be replaced. Careful consideration must be given to the conservation of them.

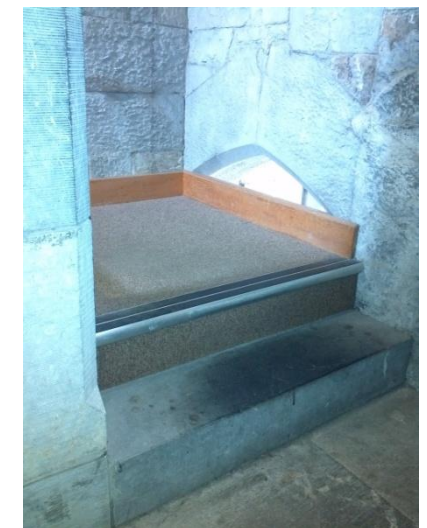
In this image we again see the stairs. It starts off as an original stone stairs and then changes to a timber frame stairs covered in carpet on the landing. They conserved as much of the stairs as possible before they had to modernise it and make the building function properly in relation to its requirements. It may not look aesthetically pleasing but this form of modernization allows us to identify what's new and what's original in a protected building

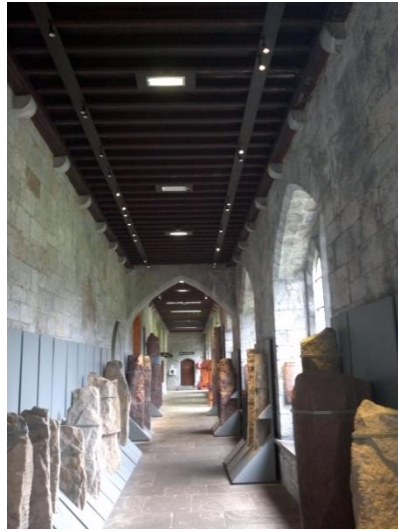
This is an image of the north wing corridor. As you can see the Oghman stones are lined up either side of the corridor. The floor surface is constructed of stone paving slabs which are there since the original build. The ceiling consists of solid oak beams running in both directions. These beams are supported by the walls and by the stone pieces coming out of the wall just below the roof. Again we see the idea of vaulted arches which give way to the concept of Tudor Gothic design.

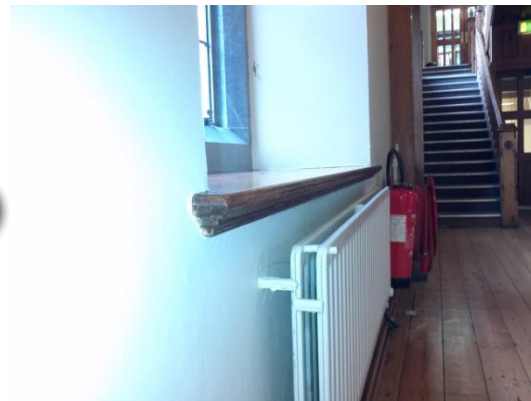
Here we see an image of the internal finishes of the east wing. The pine floorboards have been very well maintained as have the oak window boards. The stairs banister is also original and has been very well kept. The stairs itself has been modified and fitted with carpet. The conservation of the stairs is again a touchy subject but sometimes you have no choice and you must change certain parts of the building in order to make it fit for its use.

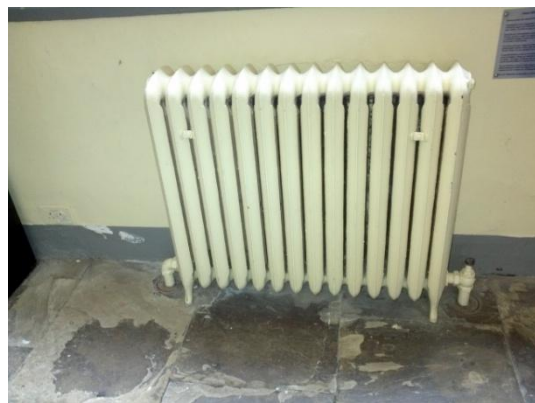
This image shows an old style radiator. this type of radiator is called a Macintosh heater. They were used quite often in older buildings to heat large spaces. It may have been installed a few years after the original construction but it is still around a long time. In my opinion any alterations or changes to this radiator must be given careful consideration in relation to conservation issues.

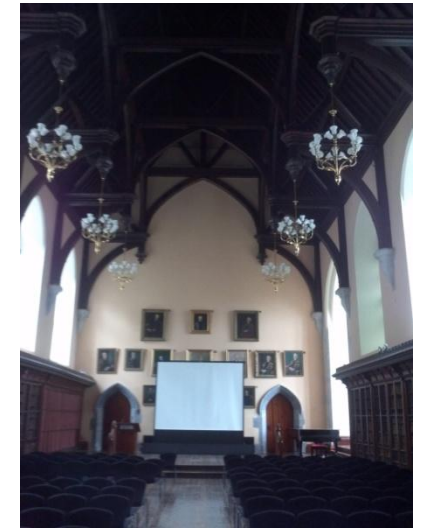
Here we have an image of the Aula Maxima. It is taken from the back of the wall looking towards the front. In it we can see the original oak flooring from 1849 and the timber book shelves running alongside either wall of the Hall. One of the most impressive parts of this area in my opinion is the roof. It is again constructed of oak. All of the pieces come together to form various vaults and arches and they give you a feeling of extravagance and openness.

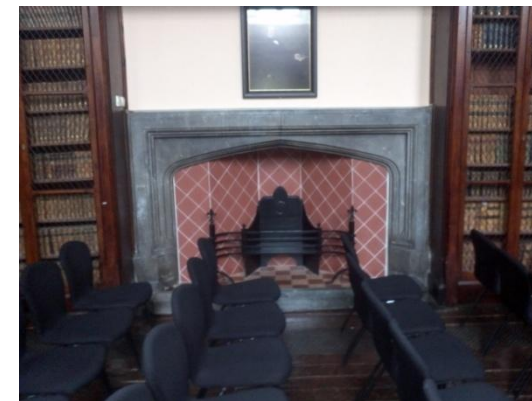
This image shows one of the various internal fire places. This fire lace is located in the Aula maxima and is surrounded by a solid stone frame. Either side of the fireplace are the oak book shelves which i mentioned in the previous photo. Both these items are very well kept and maintained. This room is probably the most historic and important room in the Quad so it is to be expected that is extremely well maintained.

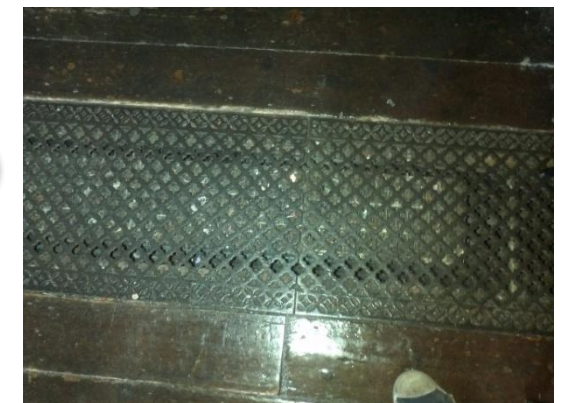
This image is again of the Aula Maxima. This time I am showing the heating system that has been installed. It is an old form of under floor heating where the radiators have been installed beneath the floor and they run up the length of the hall either side. The heat enters the room through the iron grate which can be seen in the photo. This photo also gives us a close up image of the floor boards which we can again see are very well maintained.

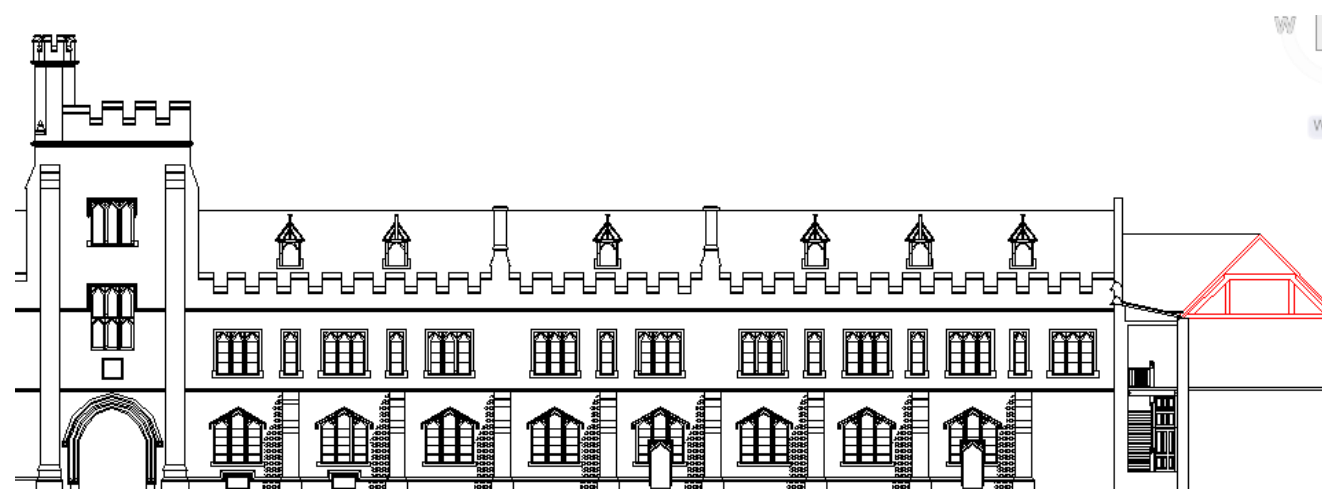
South Elevation and section through east building.

In the elevation below we can get a real feel for the Tudor Gothic design of the Quad. The First thing that stands out are all of the vaulted windows that seem to cover nearly half of the elevation. Another thing that stands out in this elevation is the tower to the left of the drawing. The huge arched entrance again gives the feel of a Tudor Gothic design.

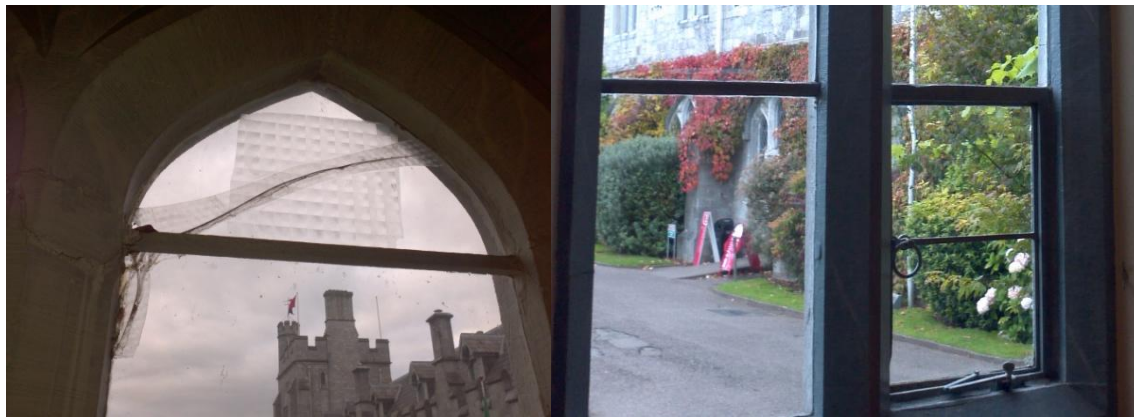
A lot of the current windows in the Quad are below the standard that would be required. The photo on the left shows cracking that has been fixed using some form of adhesive sheets. In my opinion this pane of glass must be fully replaced with careful consideration given to the conservation issues. I also believe that the aluminium framing throughout the building must be replaced and windows with opening sashets should be used. I would leave the stone mullions in place and untouched and keep as much of the original glazing as possible. The new frames would be skinny and try to resemble the old frame as much as possible without completely copying it. The replacing of these windows will provide a serious conservation issue and therefore proper research must be conducted as to the type of materials being selected. It is crucial that the overall appearance and historic feel of the building. The windows are an issue that must be dealt with but at the same time we must obey the rules of conservation and follow them vigorously.

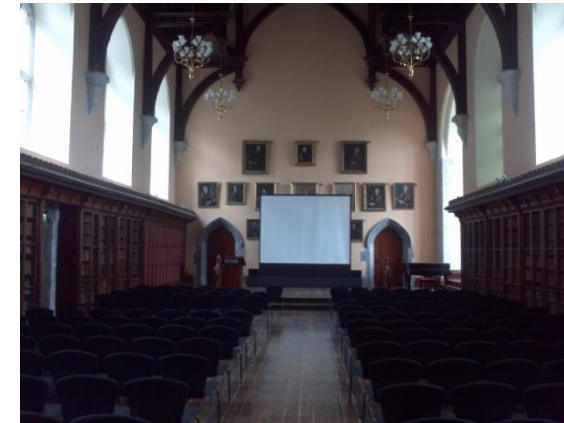
This room is currently being used for, presentations and formal events. However for my new use of offices, I plan on turning it into a canteen area which will cater for the hole building. In my opinion this is the most well maintained part of the Quad building and when incorporating the canteen I must ensure I don't jeopardise or change the overall appearance of the area too much. The current flooring in the Aula Maxima is the original from 1849 and careful consideration must be given when choosing furnishings for the canteen. The furnishings must not harm the floor. I will be leaving in the book shelves and original lighting for both conservation and aesthetic purposes.

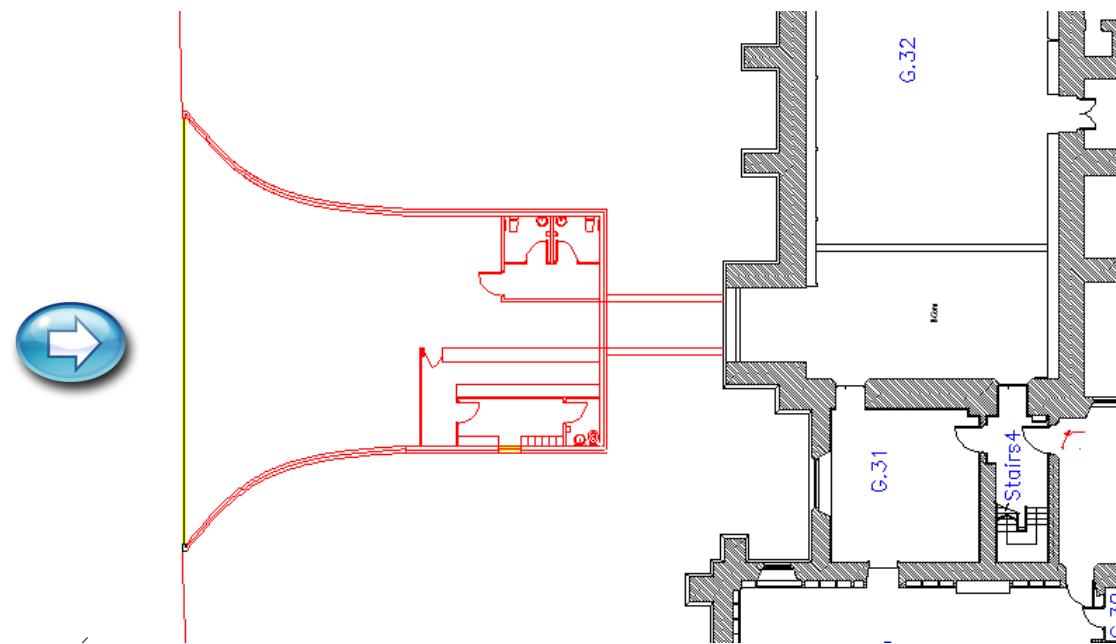
The first concept I am going to look at is an incorporation of a cafe into the building. This extension will be located at the back of the building and will be attached to the Aula Maxima. It will be constructed underground and will extend out as far as the edge of the hill on the site. A curtain wall system would then be incorporated into the edge of the hill. This extension will have no visual effect on the overall appearance of the Quad and therefore it will be no conservation issues surrounding it. It will also provide a very aesthetically pleasing view out onto the river, for people using the cafe. I was also thinking of incorporating a balcony ( location locate by the blue arrow above) to go out over the edge of the river. This balcony would also contain a stairs which would lead back up to the ground floor. It would provide a secondary means of escape in the case of a fire.

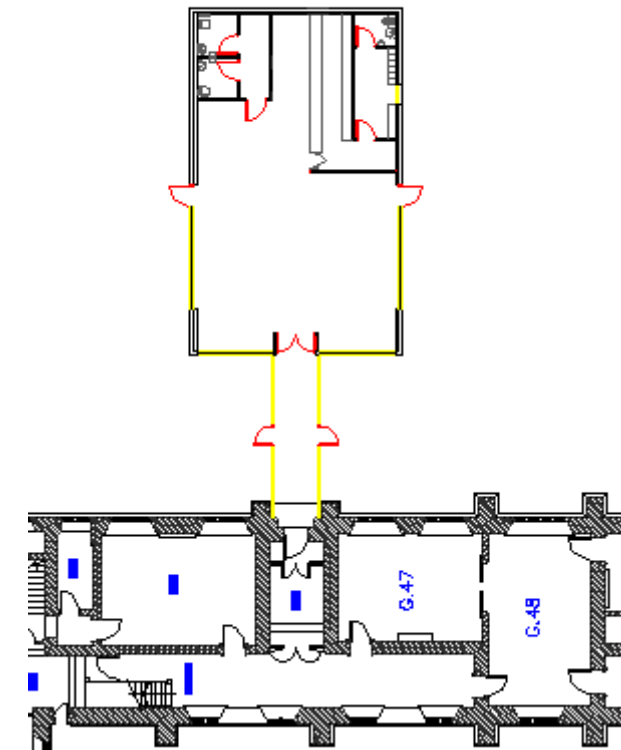
The second concept I am looking at is again the extension of a cafe onto the building. This Extension will be attached onto the back of the east wing as can be seen in the drawing above. It will be located at ground level and will contain a lot of glass. This unlike the other extension will cause a number of conservation issues. It must blend in with the original building but at the same time you must be able to tell them apart, so as to not take for the original and historic appearance of the building.
