OFFICE OF NUCLEAR MATERIAL SAFETY AND SAFEGUARDS

The MacArthur Maze Fire Study:

Evaluating the Impacts of Real World Accidents on Spent Nuclear Fuel Transportation

The MacArthur Maze Fire, April 2007

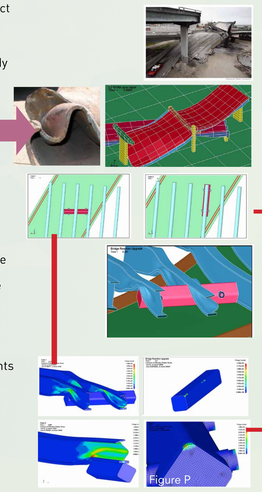
The response of the package body is dominated by the amount of girder deformation. The girders deform readily around the comparatively rigid package body, imparting plastic strains on the surface of the package wall, the magnitudes of which are within material ductility limits for all cases, with the worst case identified in Figure P.

Overpass girders (ASTM A7 structural grade steel) exceeded 900°C (1,652°F), and deformed upon impact.
