ARCHITECTURAL TECHNOLOGY

Conservation 2

Historic building material and technology

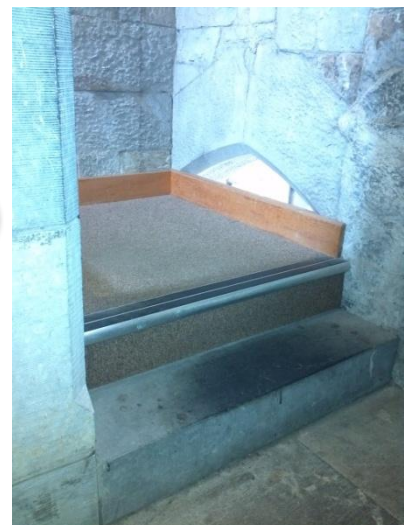
(Fig 2.12- Internal stairs)

Mixture of old and new. It starts off as an original stone stairs and then changes to a timber frame stairs covered in carpet on the landing. They conserved as much of the stairs as possible before they had to modernise it and make the building function properly in relation to its requirements. It may not look aesthetically pleasing but this form of modernization allows us to identify what's new and what's original in the Quad building

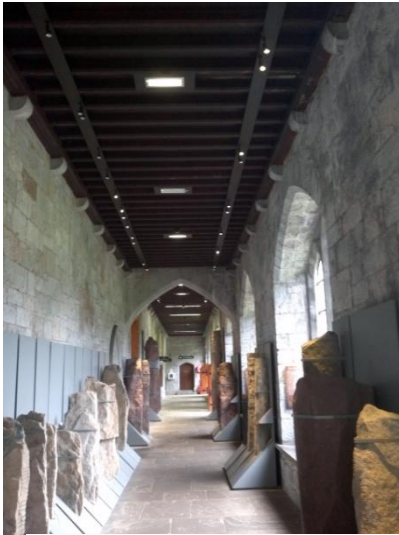
(Fig 2.13- North wing)

This is the north wing corridor. The Oghman stones are lined up either side of the corridor. The floor surface is constructed of stone paving slabs which are there since the original build. The ceiling consists of solid oak beams running in both directions. These beams are supported by the walls and by the stone pieces coming out of the wall just below the roof. The vaulted arches are again seen internally and this gives way to the Tudor Gothic design.

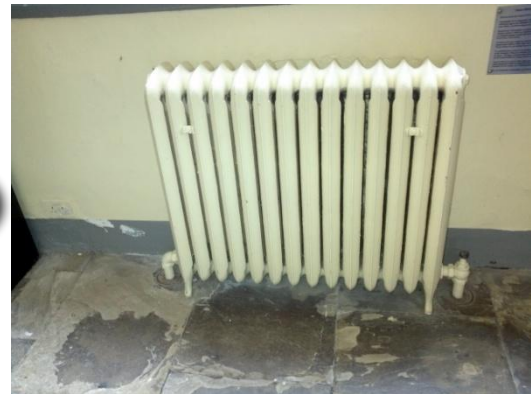
(Fig 2.14- Macintosh heater)

This is a Macintosh heater. They were used quite often in older buildings to heat large spaces. It may have been installed a few years after the original construction but it is still around a long time. In my opinion any alterations or changes to this radiator must be given careful consideration in relation to conservation issues.

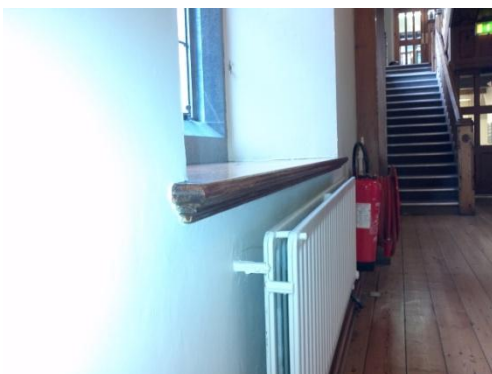
(Fig 2.15- East wing)

This is an internal image of the east wing. The pine floorboards have been very well maintained as have the oak window boards. The stairs banister is also original and has been very well kept. The stairs itself has been modified and fitted with carpet.

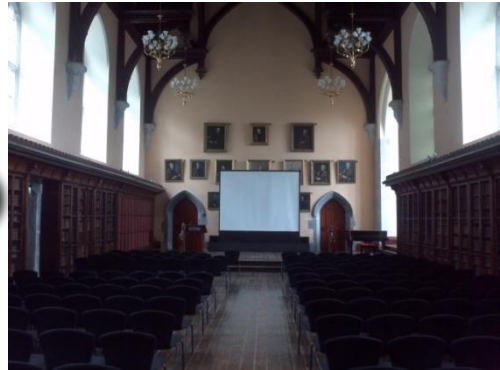
(Fig 2.16- Aula Maxima)

The Aula Maxima still contains the original oak flooring from 1849 and the timber bookshelves running alongside either wall of the Hall. One of the most impressive parts of this area in my opinion is the roof. It is again constructed of oak. All of the pieces come together to form various vaults and arches and they give you a feeling of extravagance and openness. This area has been extremely well kept and conserved.

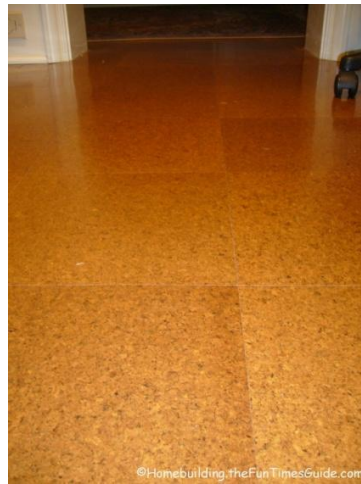
(Fig 4.1- Cork Flooring)

There are many areas of special interest throughout the Quad building. The first area I am going to look at is the Aula Maxima. For the purpose of the new use I will be turning the Aula Maxima into a canteen/recreation area. In order to do this I had to come up with a strategy to protect the floor from excessive wear and tear. I have done this by covering it in cork paving slabs.

These slabs can be easily installed and removed. They are also breathable and renewable. They will protect the original floor whilst allowing it to breathe and it is completely reversible.

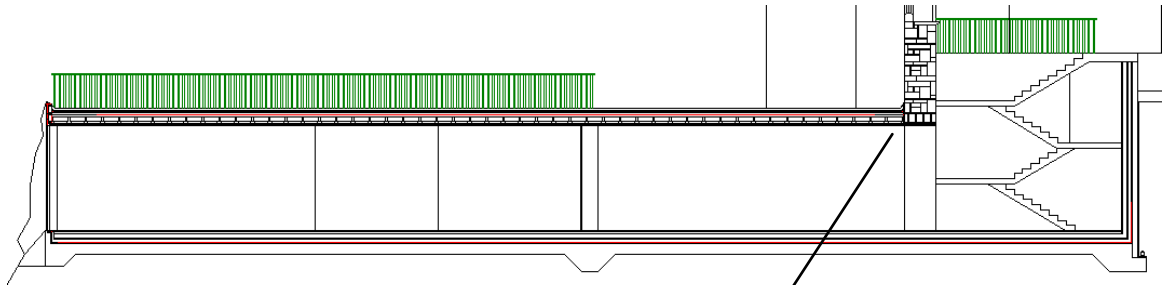
(Fig 4.4- Section through extension)

The area of most special interest is the cutting away of the section of a foundation to allow the extension to come in underneath the original building. This is a major form of intervention and has been given careful consideration. I choose to go underneath the Quad mainly because I did not want the extension to have an effect on the appearance of the Quad. The Quad is the most historic building on the campus and I felt it would be a

crime to attach the extension onto the building and therefore I choose to go beneath the ground and hide it from the eye. The extension will be attached as seen below.

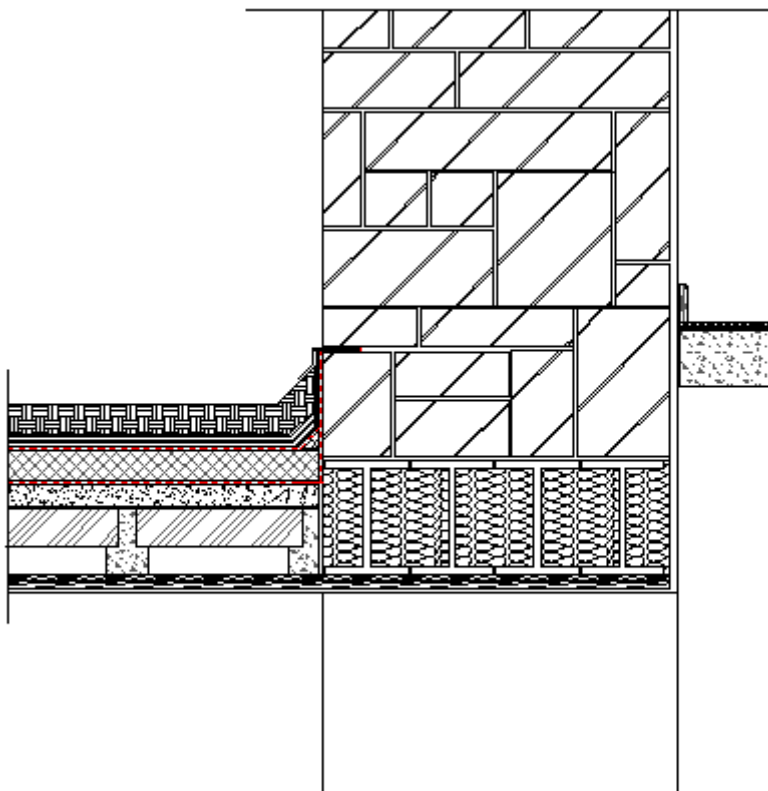
(Fig 4.5- Detail of the extension meeting the Quad. See appendix for more extension details)

As this is a major form of intervention it would be essential that specialists be brought in to prop up and secure The existing wall in order to allow the above detail to be carried out. The work must be carried out with the greatest of care, in order to avoid any damage or cracks to the original building. All works must be carried out by specialists with expertise in the area of conservation.
