EARLY CHILDHOOD CENTER

ELEVATIONS
EARLY CHILDHOOD CENTER
SOUTHERN ILLINOIS UNIVERSITY
EDWARDSVILLE, ILLINOIS
8 MAY 2024

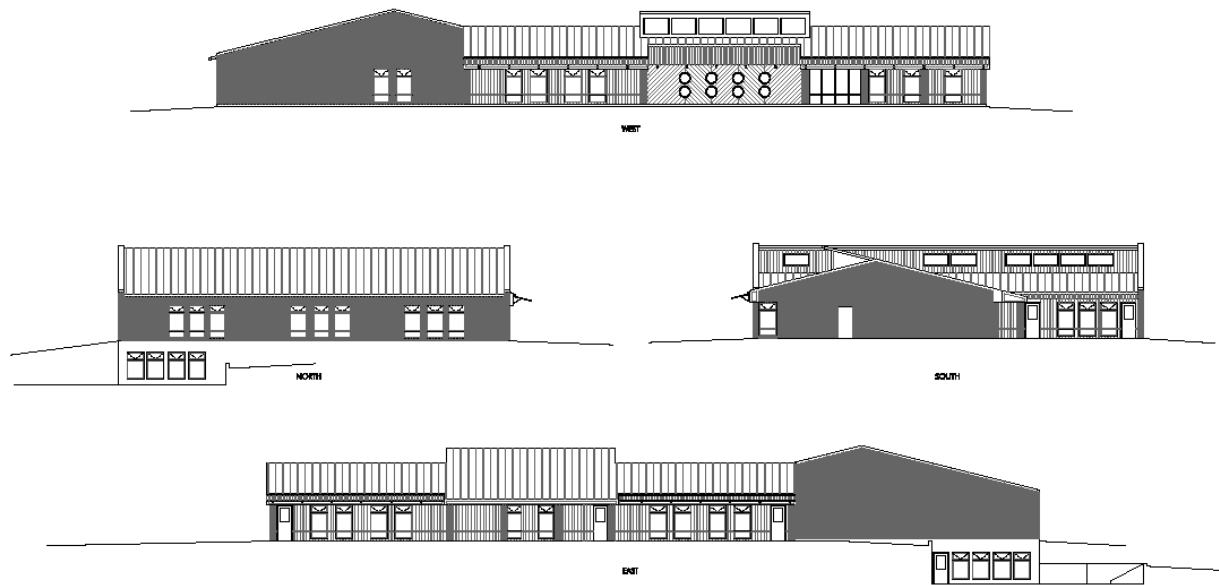
- The building is outside the “core” campus area and therefore has more flexibility under the Campus Design Guidelines.
 - For compatibility, exterior walls will match the existing building and be primarily brick masonry.

- The sloped metal roof was replaced in 2005 and the preference is that it remain relatively intact and that the new roof match. This is consistent with “buildings beyond the core.” A canopy has been added both front and rear for covered access to the entries.

Elevations

- To resolve functional issues and improve energy efficiency, all exterior windows will be upgraded to new anodized aluminum frames and insulating glass. To minimize children exiting through windows, I recommend a 16-20” hopper unit for the top unit in the assembly.
