Observation of Framing Layout above Bow Window

Analysis of Platform Framing Construction

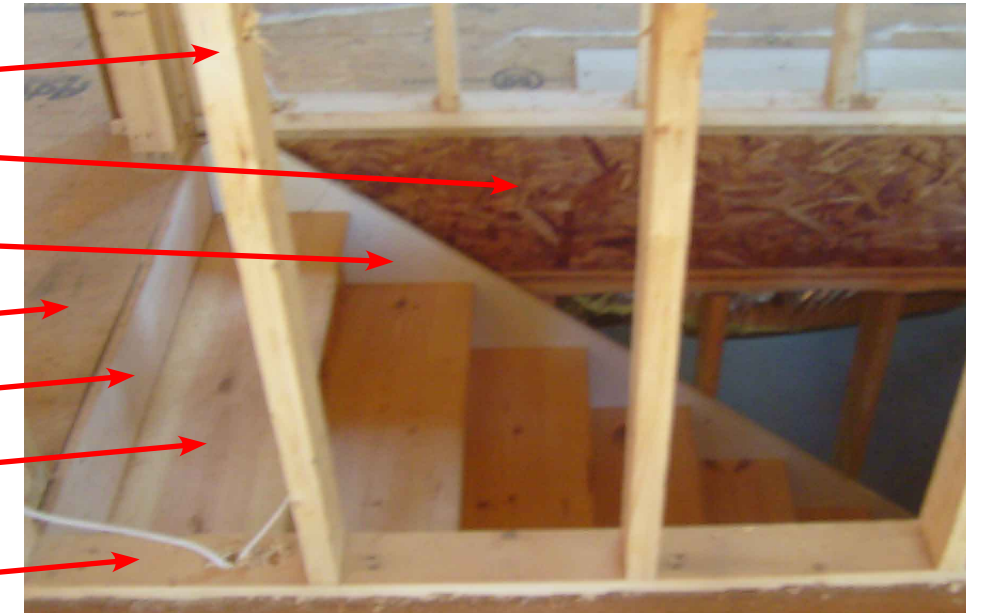
Observation of Stair Components into basement area and framing out of floor area around it

- HVAC RUNNING THROUGH I-BEAM
- GEORGIA PACIFIC I-40 I-BEAMS
- 2 X 4 DOUBLE TOP PLATE
- OSB SHEATHING
- 2 X 4 P.T. SILL PLATE
- CONCRETE FOUNDATION WALL
- 2 X 4 WALL STUD FRAMING
- 2 X 4 BASE PLATE
- CONCRETE SLAB

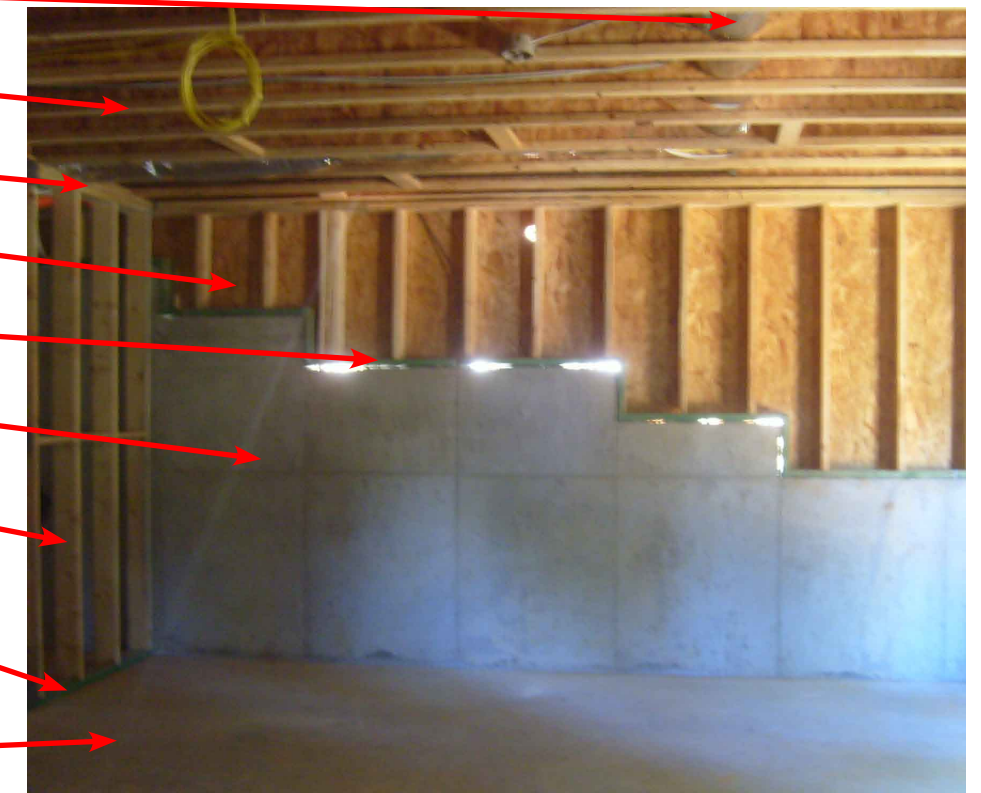
Observation of Foundation Wall system and how it steps down to create basement condition
