The objective was to redesign the current Bamboo Bike produced by Alabamboo.

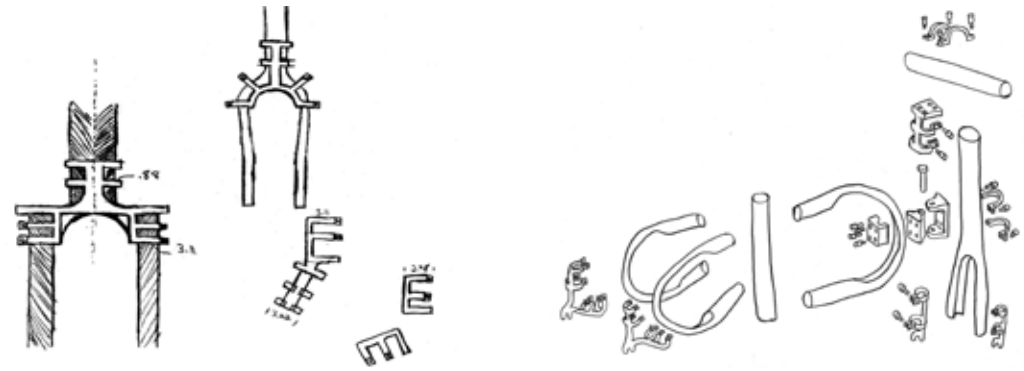
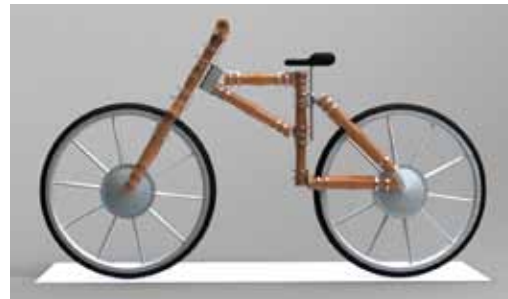
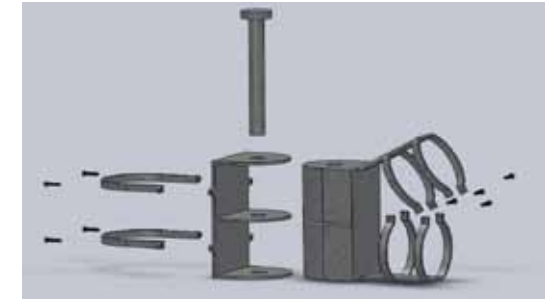
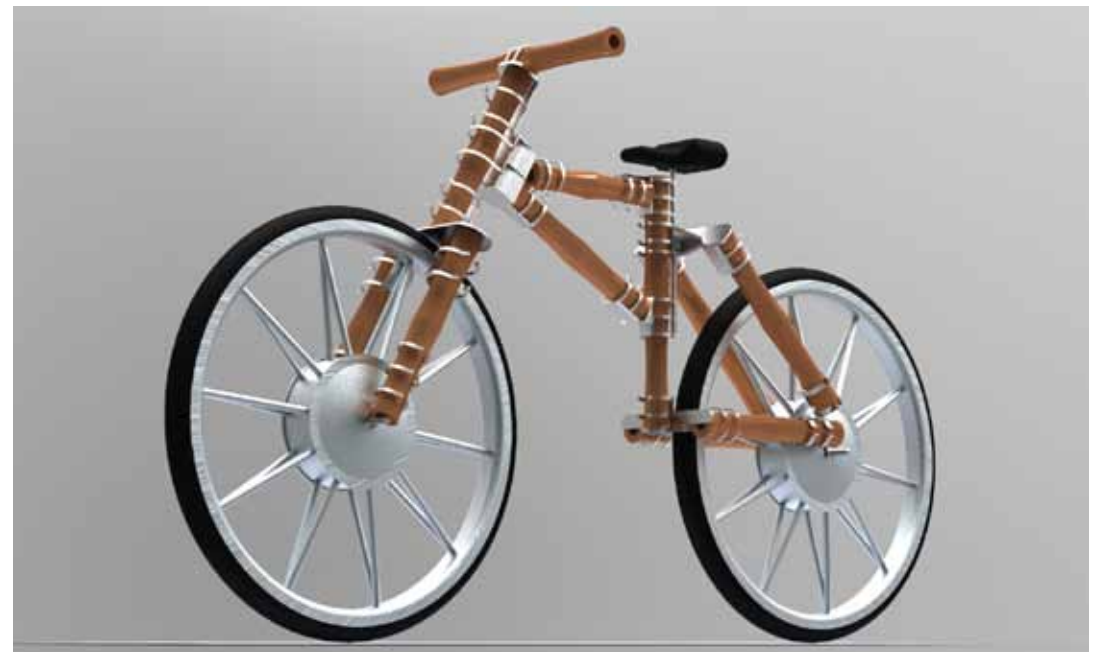
To eliminate the need for Resin and to make the entire bike repairable a metal band system is used. Each joint uses metal bands that rap around the bamboo and tightened. This uses the bamboo's natural compression for strength.

By using the band system only the joints and wheels need to be shipped allowing the customer to use local materials for the body of the bike.
